We are constructing a health centre and kindergarten space for the community of Mayuge in Uganda.

EfOD NW: An Update from Uganda Week 4-6

A SUMMARY OF THE LATEST SITE ACTIVITIES AT KATHY'S CENTRE

15/09/16

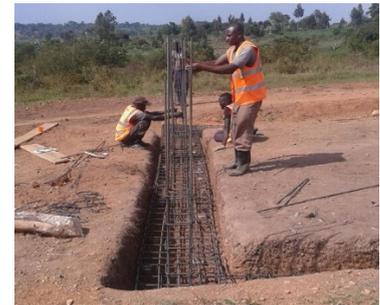
Substructure reinforcement

The reinforcement cages were in place with starter bars for the columns.

was in safe hands. She spent a week with the previous group familiarising herself with the design and practices. During the 4th week she immediately got hands-on by digging the remaining strip footings and levelling the ground for the floor slab. 9.5m long reinforcement cages were lifted into the footings and bars tied together, including column starter bars. Concrete blocks were cast in strips and broken to make spacer blocks.

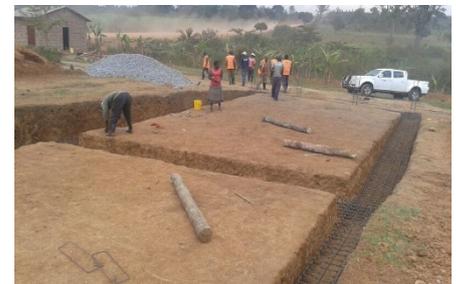
Strip footings

The footings indicate the extent of the building. ISSB walls will be laid on top, with columns at regular centres. The building is divided by a central wall which aids stability.

In the fifth week, Matthew Jack (Jacobs) and Andy Banks (4way Consulting) arrived in Mayuge. They oversaw the casting of the concrete foundations which was done in sections and finished with a fuel driven poker.

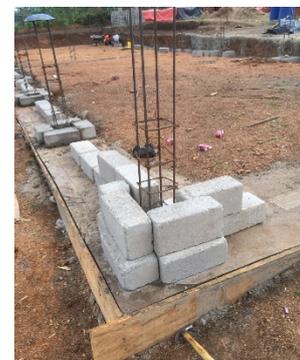
Beginning the superstructure

The first few courses of the wall are being formed with concrete blocks. Before mortaring, the team checked the block arrangement around columns, which will act as permanent formwork when the concrete is poured.
