We are constructing a health centre and kindergarten space for the community of Mayuge, Uganda.

EfOD NW: An Update from Uganda Week 2&3

A SUMMARY OF THE LATEST SITE ACTIVITIES AT KATHY'S CENTRE

31/08/16

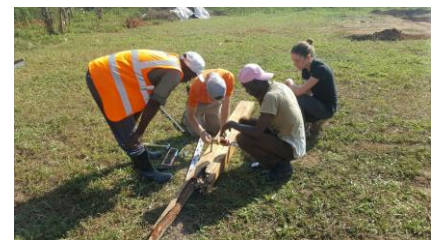
Shear Link Production Commences

The first shear links are being constructed and fixed. Both the EFOD members got hands-on with fixing.

Week 3 commenced with continued ISSB production and forming of shear links for strip foundation. It was essential to explain how fixing of the reinforcement must be accurate to ensure it is constructed as it was designed.

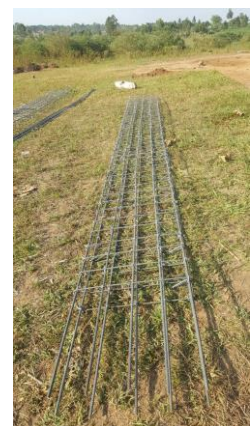
First Cage of Reinforcement

We are using reinforced concrete for the foundations, columns and ring beam. This is the first cage of reinforcement for the foundations.

Week two consisted mainly of excavation for foundations and ground floor slab. The last day of week two marked the delivery of our foundation rebar, enabling the construction of reinforcement cages. Despite none of the workers having ever used reinforced concrete before, they were keen to learn about its benefits and why we have specified it.
